# Coming Out On Top

The stars aligned during the long-term restoration of a **1971 Mercedes-Benz 280 SE 3.5 Cabriolet** to produce a hugely authentic car and benefit all involved

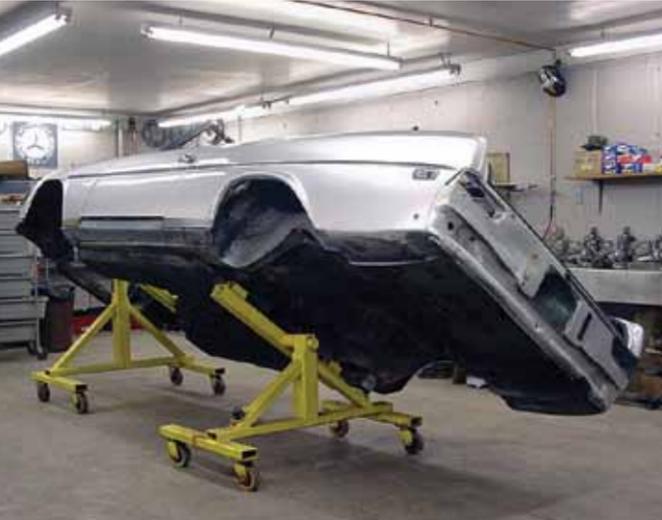
**1** Gernold built a jig that raised the car to a comfortable working height, tilted for ease of access and rolled so he could readily transport the shell.

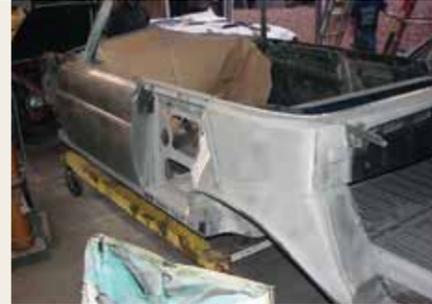
**2** The unit-body car's integral rear fender had sideswipe damage and a bit of rust; it was completely replaced with new sheetmetal.

"It lived by the ocean with salty air, and the convertible top was left down through some rainstorms," Gernold explains. "Water had collected in the bowl-shaped depression under the back seat, where the metal rusted, and there'd been a minor accident up front and poorly repaired side-swipe damage to the driver's rear quarter. The top itself was in lousy shape, and although it was difficult to spot, this car was wearing a sedan front bumper, because the price difference between that style and the correct one for a Coupe or Cabriolet is staggering."

The accident-affected fender and rear quarter panel skin were replaced with factory new sheetmetal—the latter being a complex job that was done in expert fashion—and the rear floor section was cut from the Coupe and expertly placed in the Cabriolet. Those repairs completed and the car stripped to bare steel, it was treated to a new basecoat/clearcoat finish in the original 906 color using the OEM BASF Glasurit paint system; this all-inclusive paint system is very expensive, with Gernold noting that a single gallon of some Glasurit paints can cost \$800. As expected, the paintwork was done to factory standards.

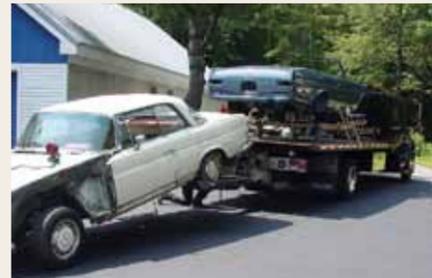
**3** The white 280 SE 3.5 Coupe donated a floor section and other parts to the Cabriolet, here seen returning from the body and paint shop wearing its original color.

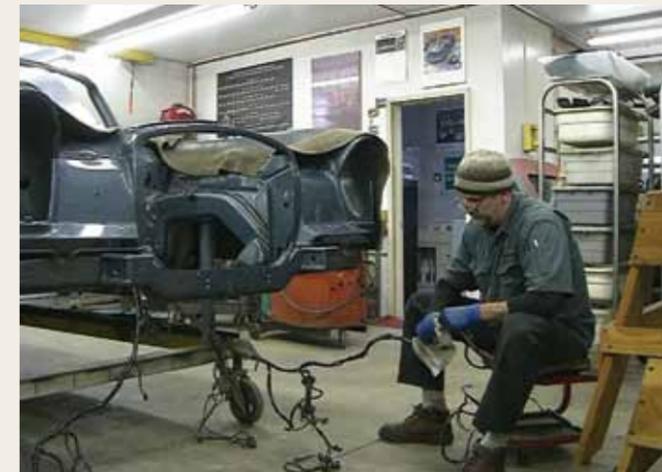
**4** Gernold installed a new wiring harness in the Cabriolet; this replacement part was sourced directly from Mercedes-Benz.

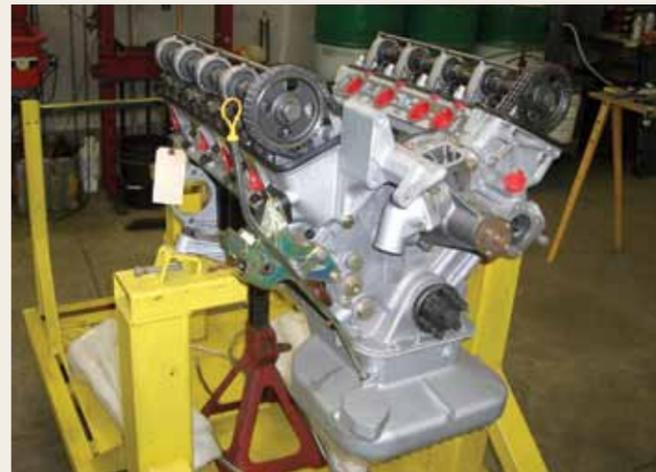
**5** Metric Motors rebuilt the complex SOHC V-8, and cosmetics and final assembly were completed at SL-Tech.

While the body was being perfected, Gernold sent the V-8 to the Mercedes engine specialty firm Metric Motors, in Canoga Park, California, for a full rebuild; this would eventually be reinstalled with a new wiring harness. He made a shocking discovery with the automatic: "I found that the transmission filter was original to the car—it hadn't been replaced in 30 years, and was full of sludge!" he says with wonderment. "Doing this level of restoration, I couldn't leave anything to chance, so I sent the transmission out to be rebuilt." He also rebuilt the front and rear suspensions, as well as the rear axle that had a cracked slip joint that is often overlooked.

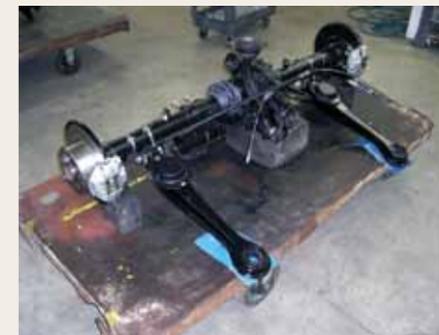
**6** The rear axle assembly was completely restored with a replacement slip joint and all-new disc brake components.

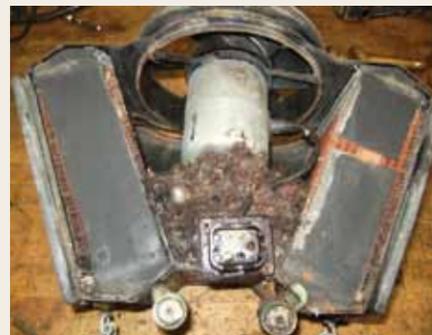
**7** The bulky under-dash heater/de-froster/air conditioning blower unit was found to contain a mouse's nest.

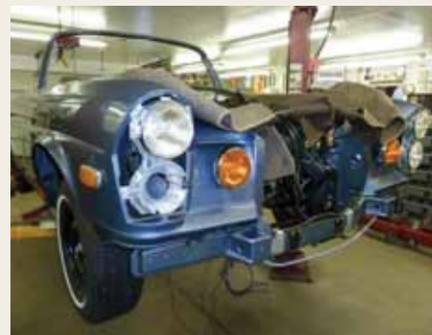
**8** All front lighting components, from headlamp buckets and chrome surrounds to the orange marker lamps, were purchased new.

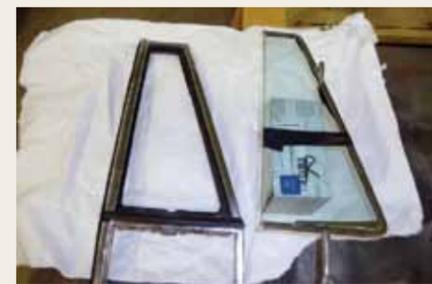
**9** The window frames were rechromed, and Gernold installed no-longer-available NOS vent window gaskets.

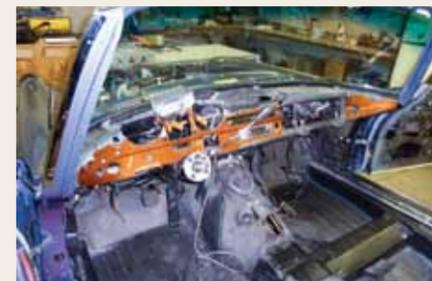
**10** The interior's original rosewood trim was in fine condition and was refinished by Madera Concepts before it was reinstalled.

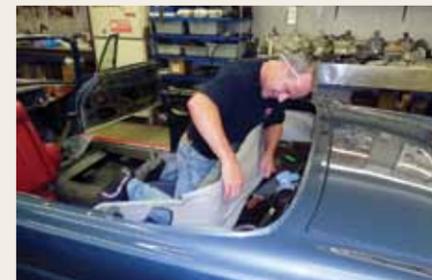
**11** Every gray surface in the 3.5 interior is either leather or carpet. Here the convertible top well trim was expertly fitted.

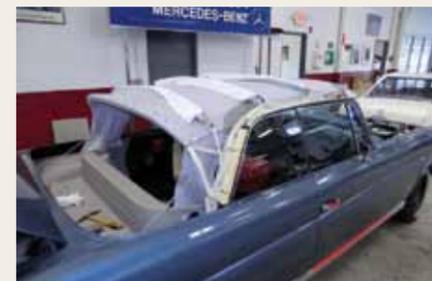
**12** The convertible top bows were stripped and repainted, and the wooden supports remade, before the new multi-layer top was installed.

and every piece of wood in it was remade, every piece of chrome replated. It cost \$20,000 to do that top alone—it's quite a job."

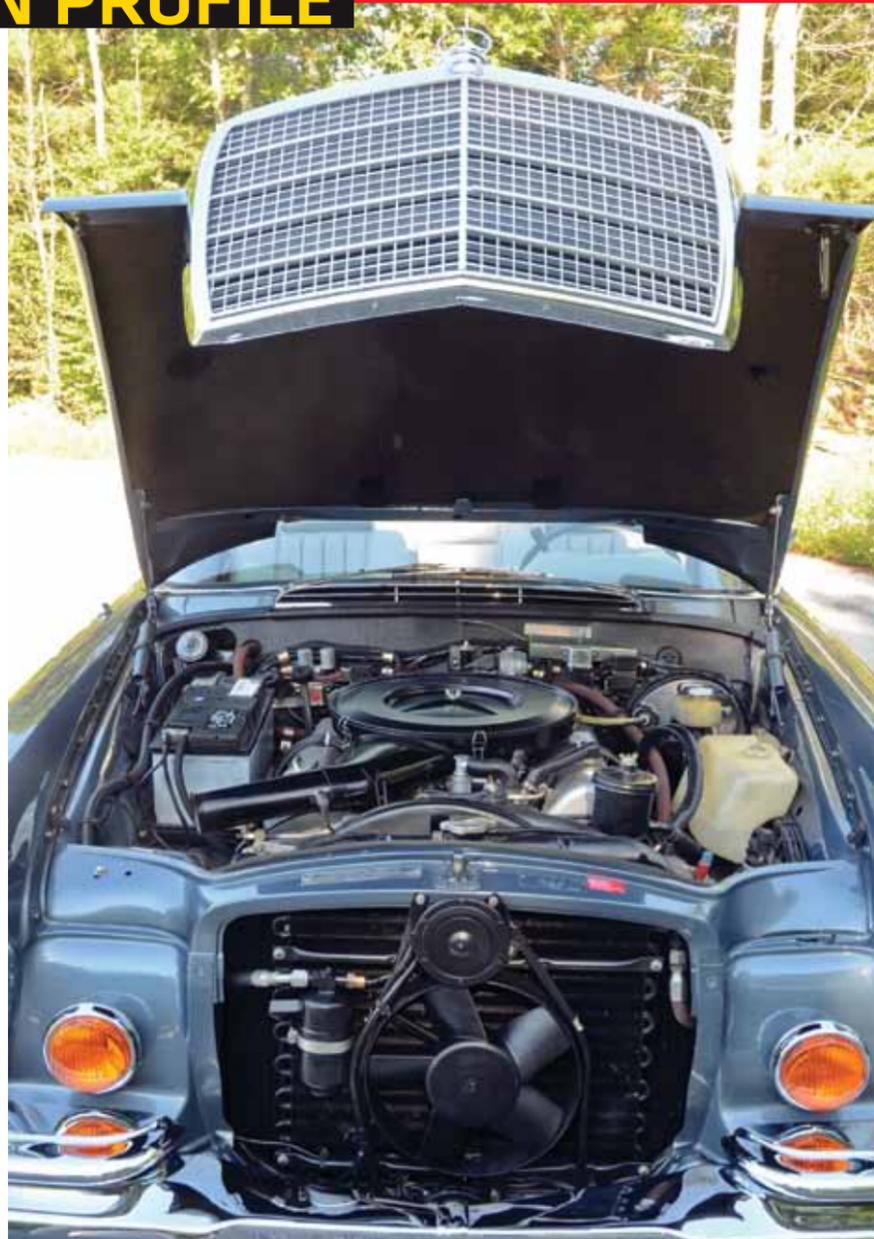
**Because this 3.5 was stripped to a bare shell, there isn't one component that wasn't fully restored or replaced with a new OEM piece. The M116 V-8 was rebuilt in California and reassembled in Maine. There's an estimated \$1,000 in firewall grommets alone.**
