# Coming Out On Top

The stars aligned during the long-term restoration of a **1971 Mercedes-Benz 280 SE 3.5 Cabriolet** to produce a hugely authentic car and benefit all involved

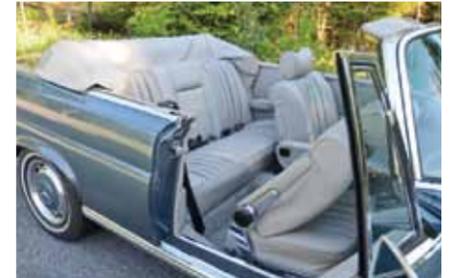
Although an interior can still be made from scratch, using a top-quality kit from a noted supplier costs one third as much.
